# Garrett Wade

## Technical Memo T21

Re: 23N02.01 23N02.02 23N02.10

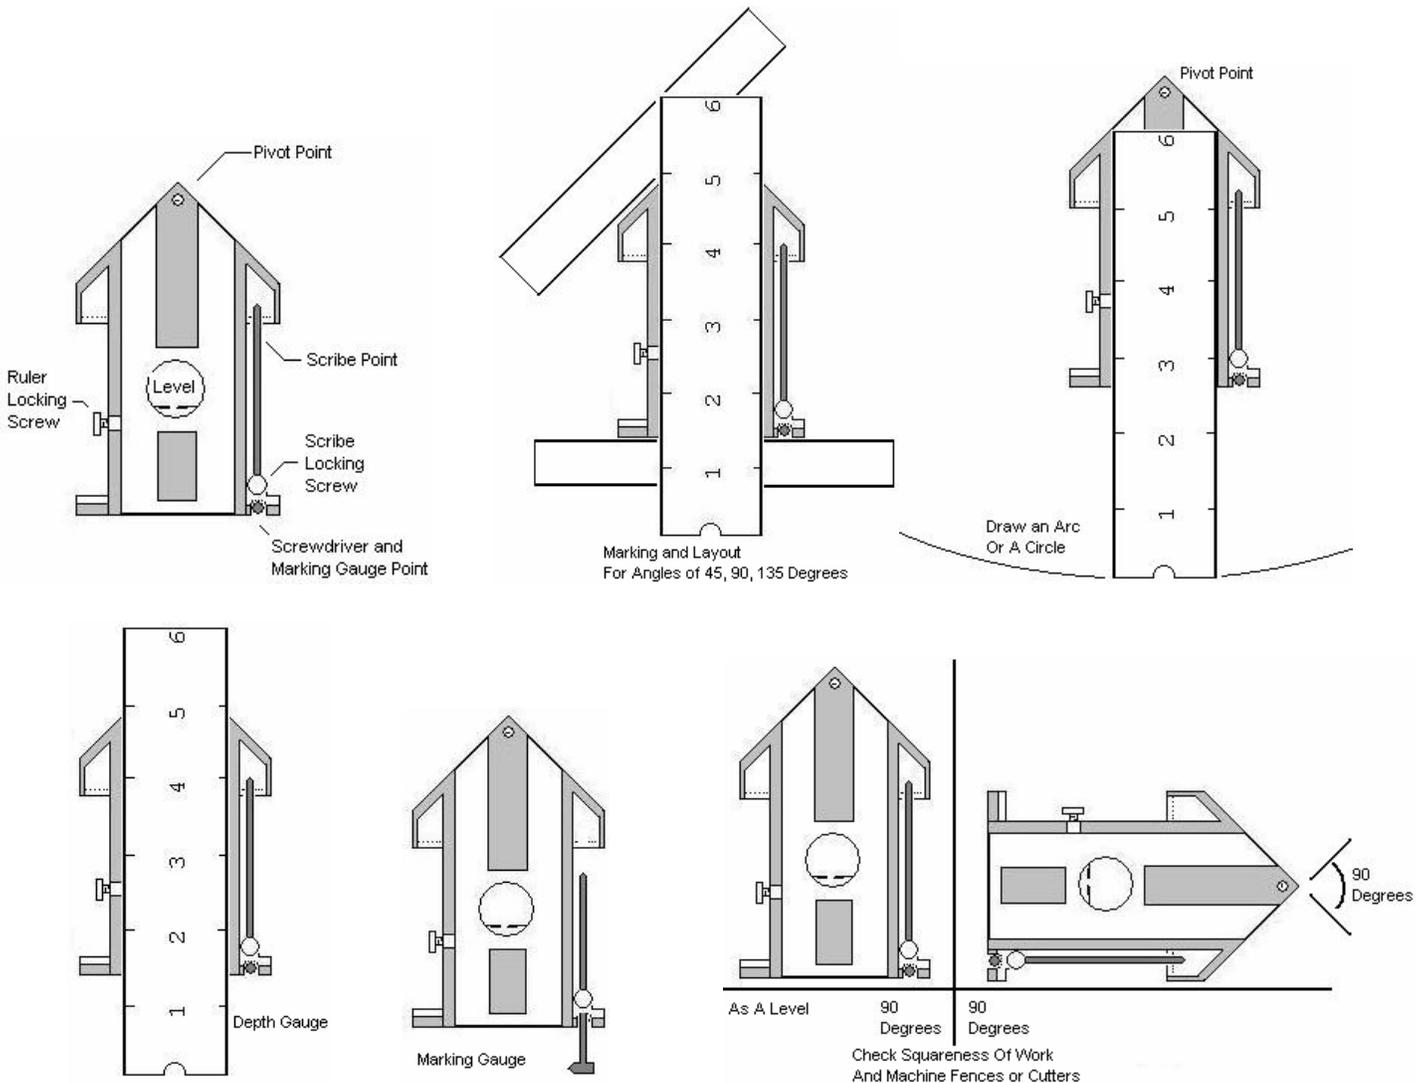
**Special Note:** Sometimes the screwdriver end on the scribe does not fit the slot of the pivot screw. This can be easily corrected with a small file by removing any burrs left on the tip from the machining process. Simply filing the flats of the tip a few times will correct the problem.
